**ELECTRONICS COORDINATING OF**  
**SHIP PREPARATION**  
**and**  
**TARGET INSPECTION**

**FINAL REPORT**  
**TESTS ABLE AND BAKER**

**VOLUME 2**  
**PHOTOGRAPHIC RECORD**

**DIRECTOR OF SHIP MATERIAL**  
**JOINT TASK FORCE ONE**  
**OPERATION CROSSROADS**

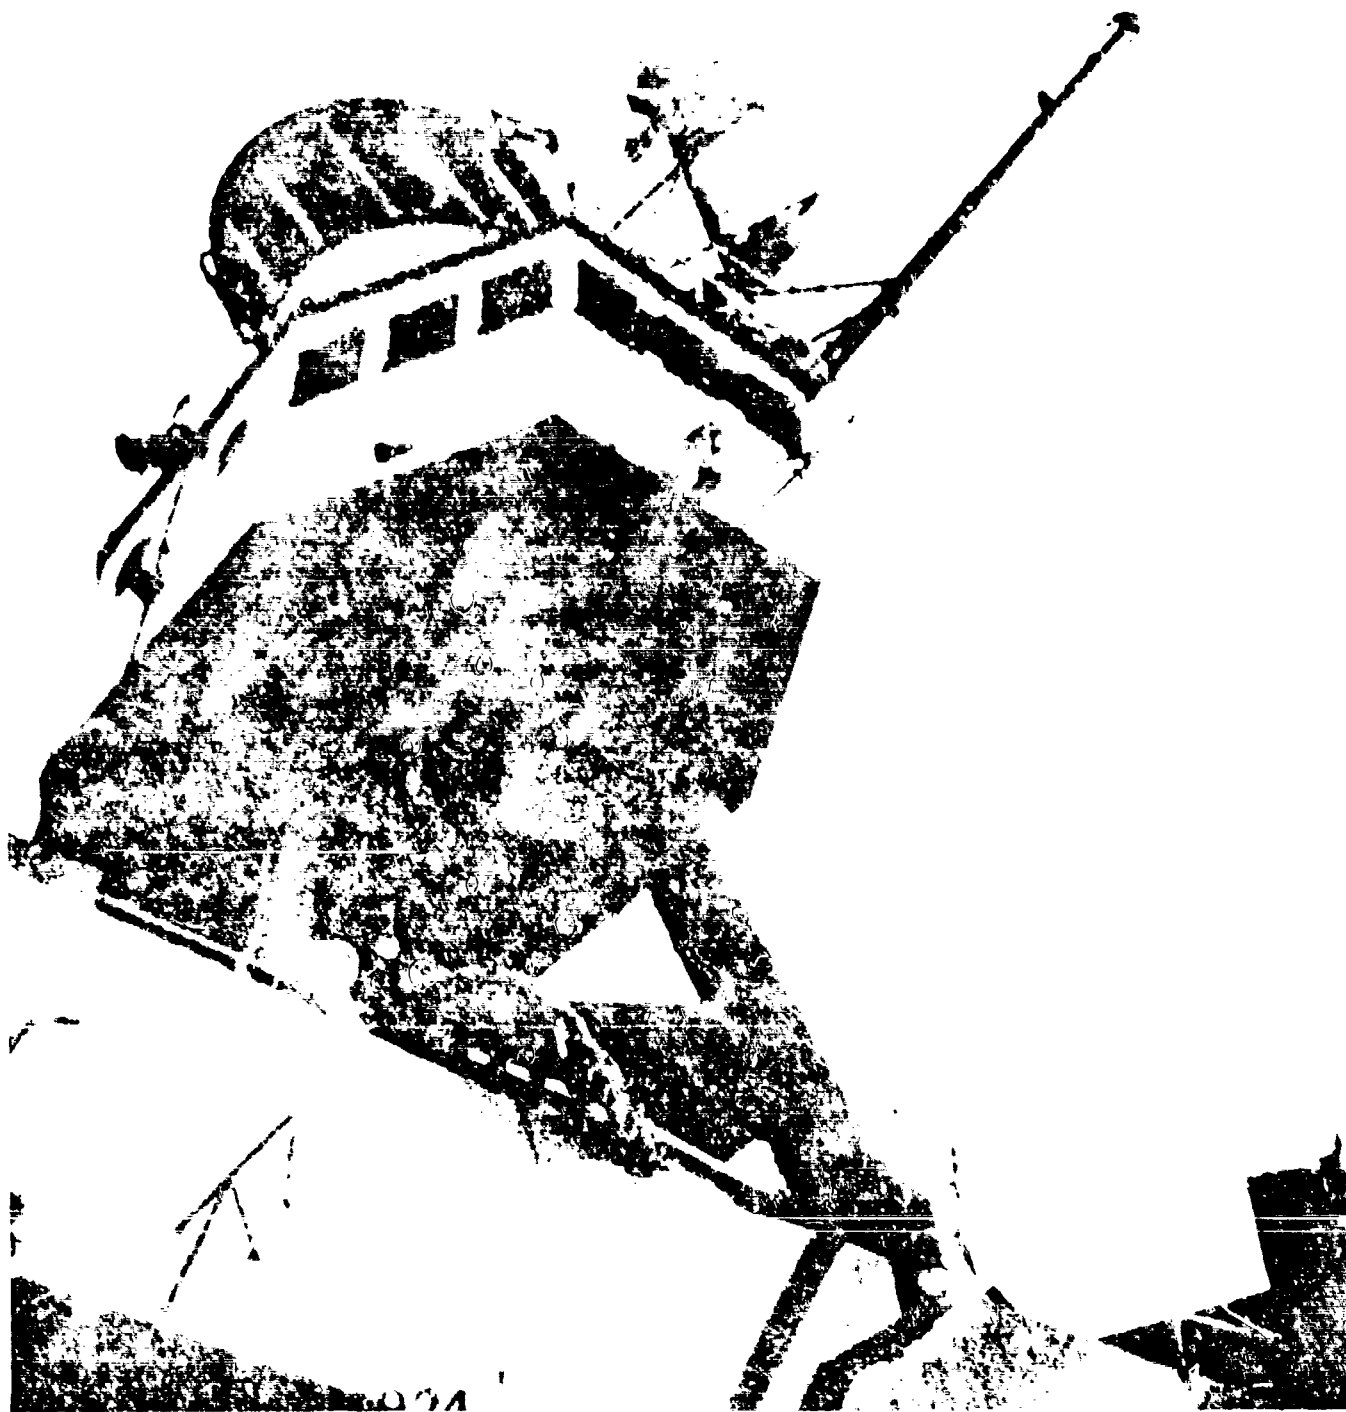
POST ABLE - FORWARD SUPERSTRUCTURE AND FOREMAST. View of general damage caused by test.

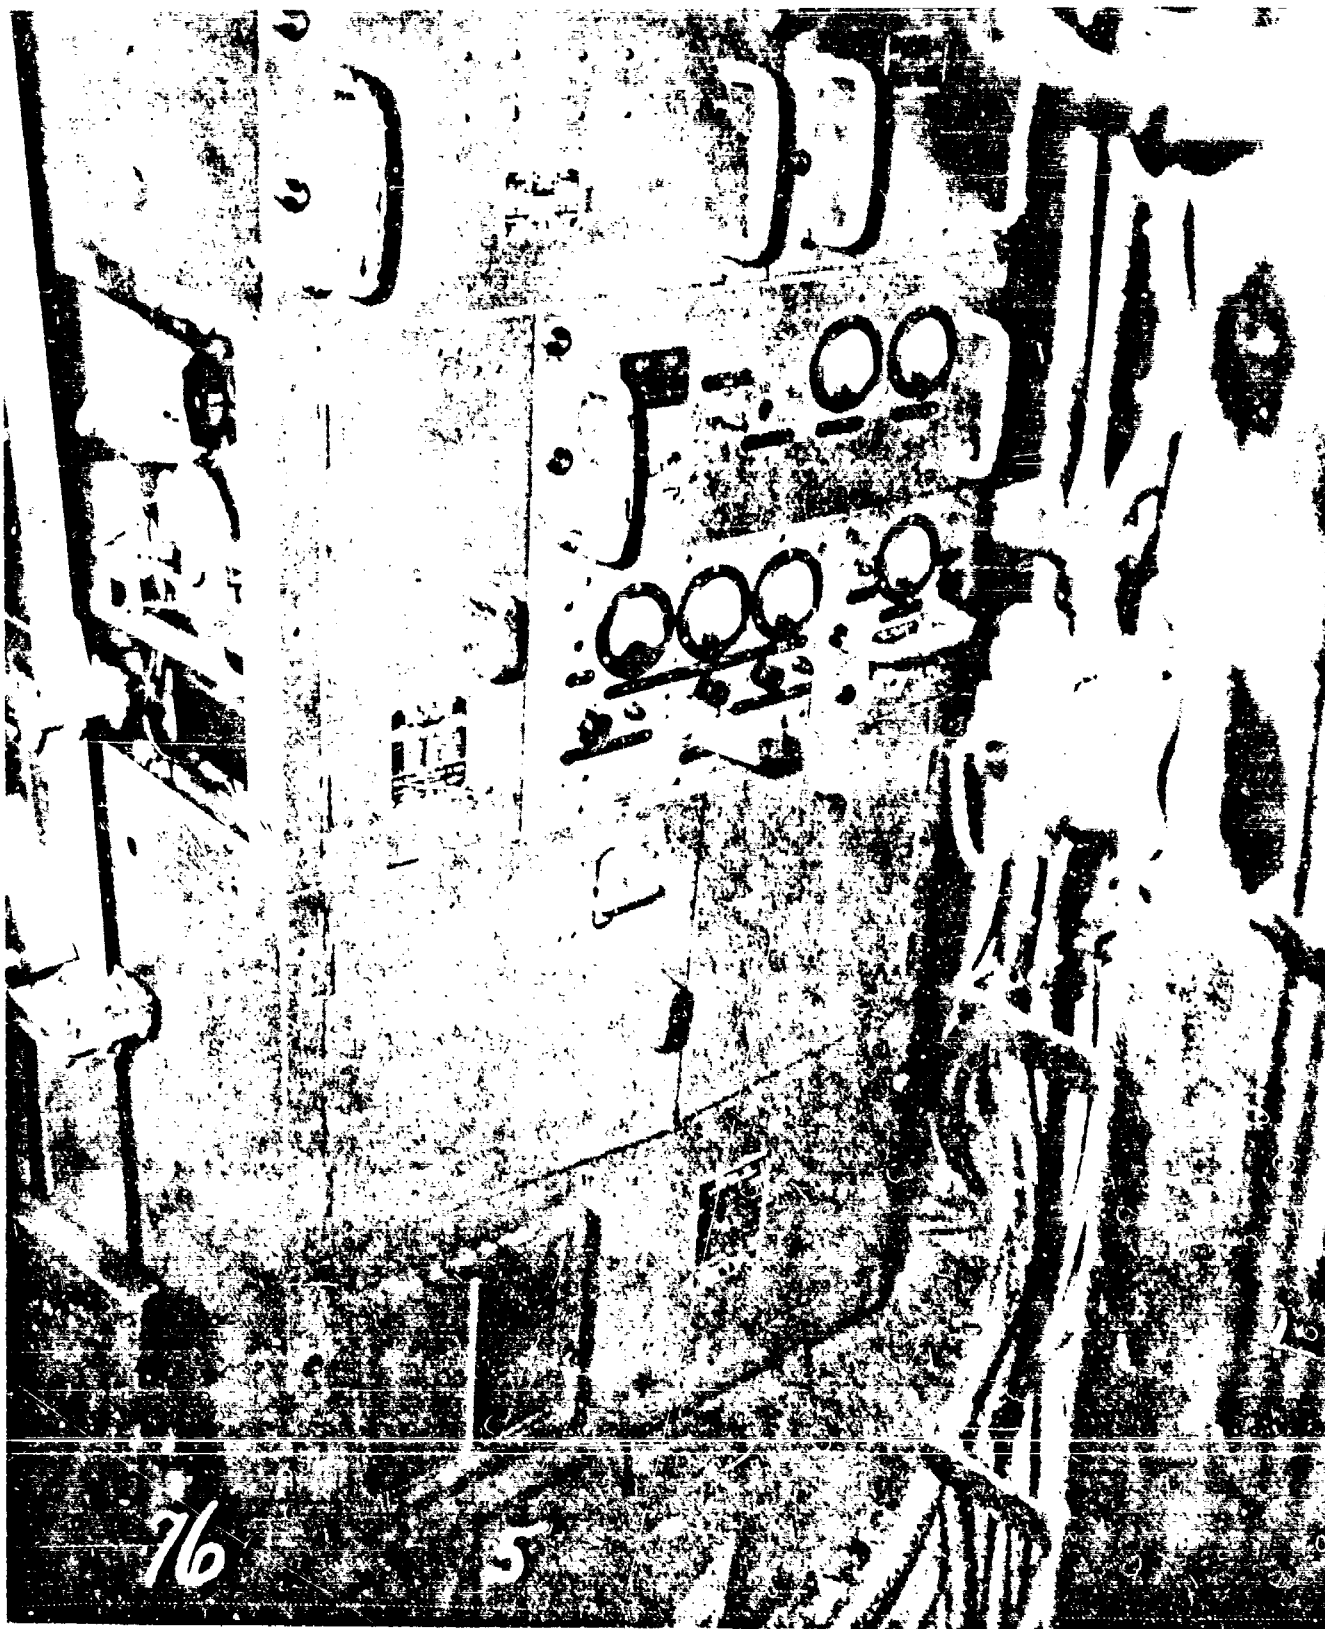
POST ABLE - FORWARD SG TRANSMITTER. The damage to this unit was greater than that apparent here. The bulkhead tilted the transmitter forward and the frame was so distorted that the transmitter doors would not close and drawer type units would not slide. Cables running up the side of the unit were torn and several were open. The wave guide was distorted causing crystal protector, (a) to jam.

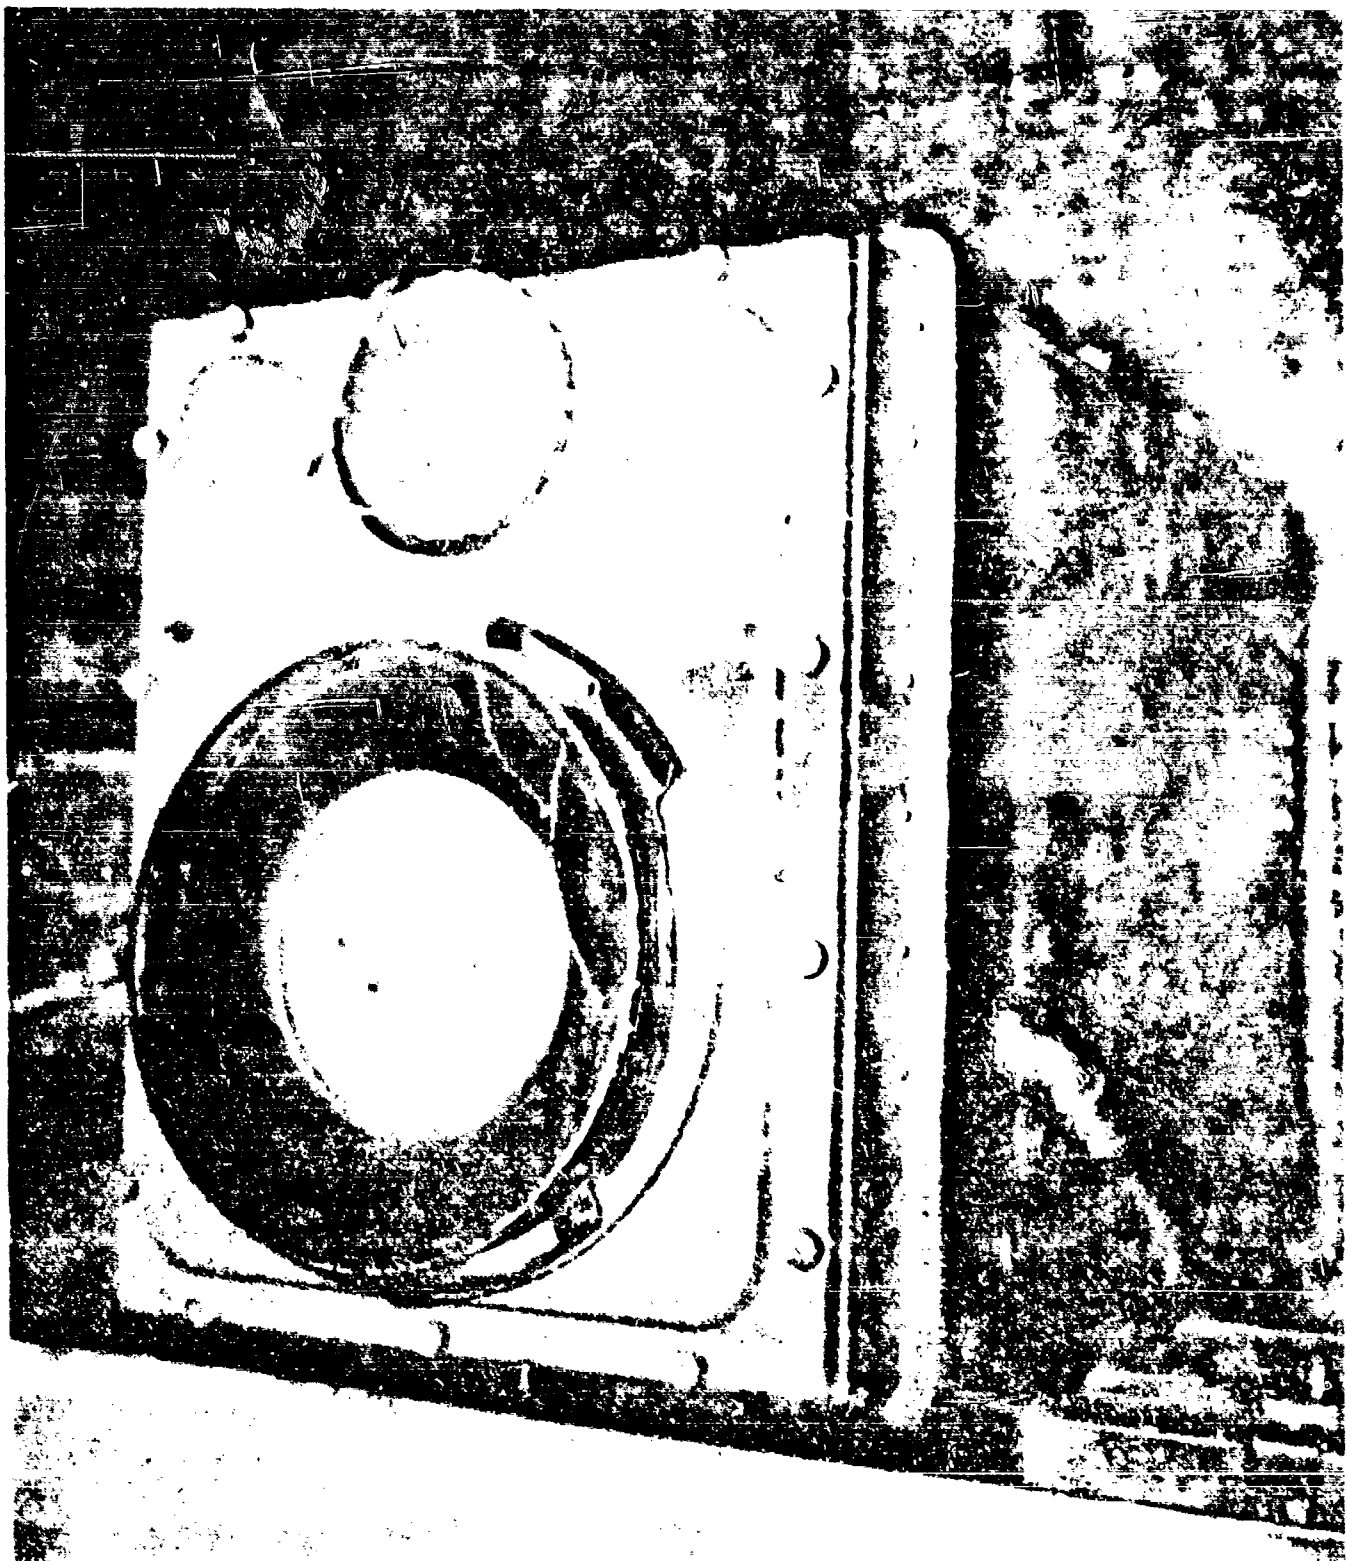
POST ABLE - VD-2 PPI REPEATER. The plastic cover over the PPI tube was broken. This had no effect on the operation of the equipment as the tube itself was not broken.

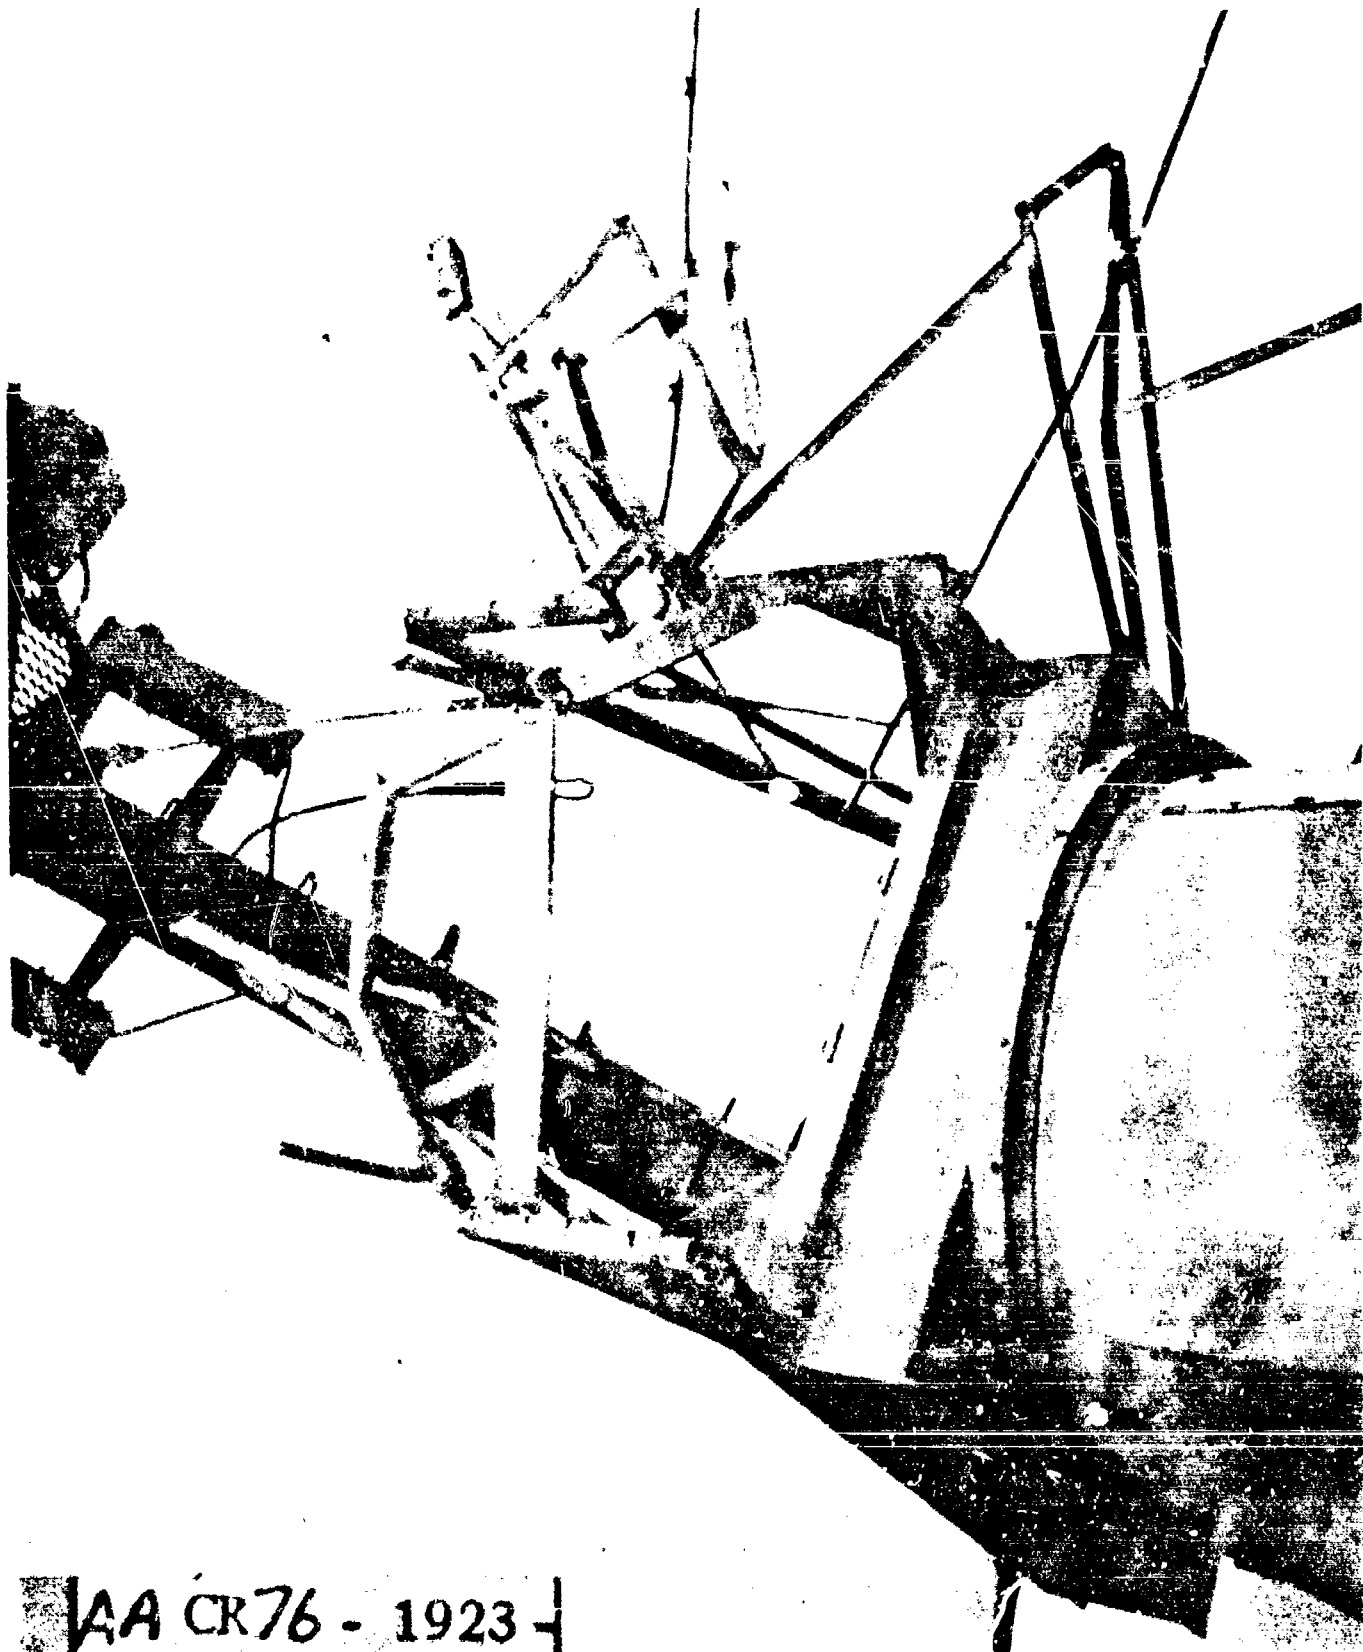
POST ABLE - SK PEDESTAL. Fragments of antenna remaining.

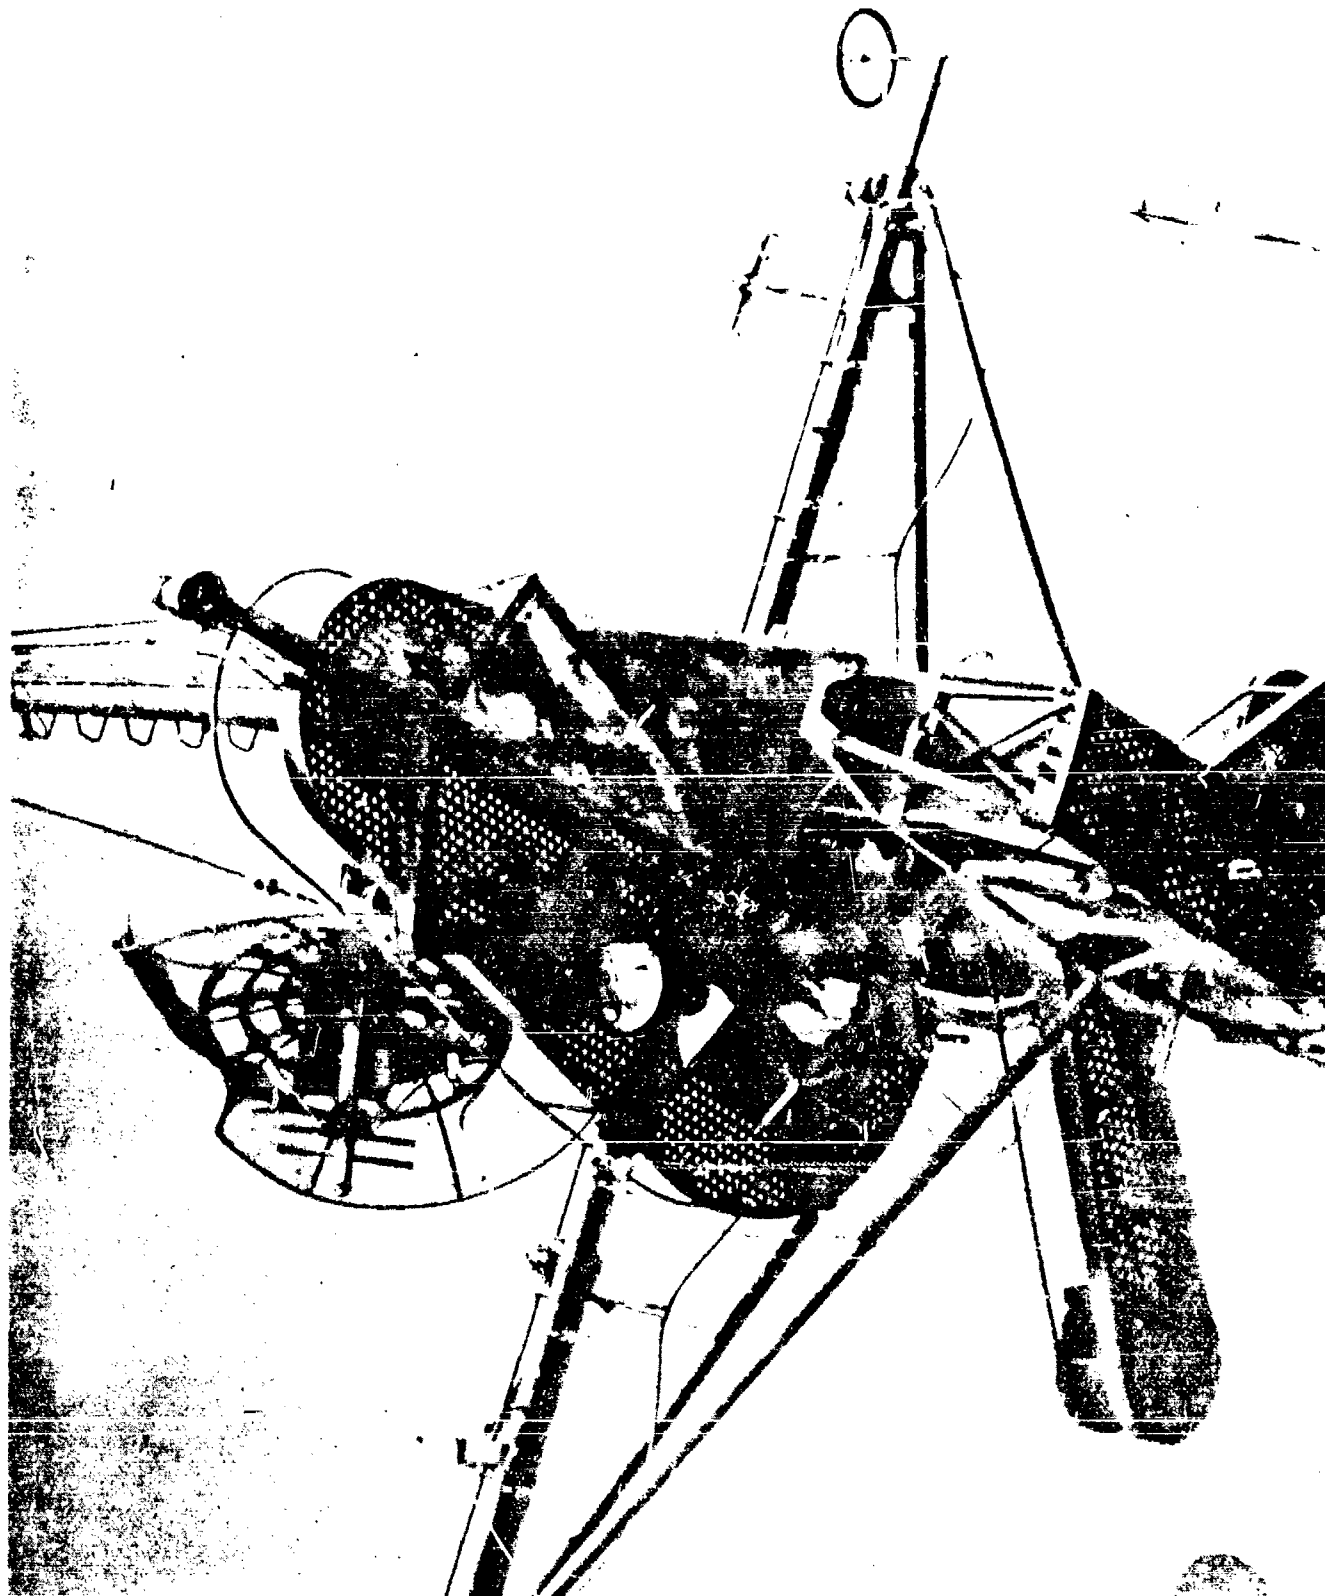
POST ABLE - SP ANTENNA. Echoes were received in spite of damaged condition. Beam pattern was affected, and complete rotation was impossible due to damaged drive assembly in pedestal.

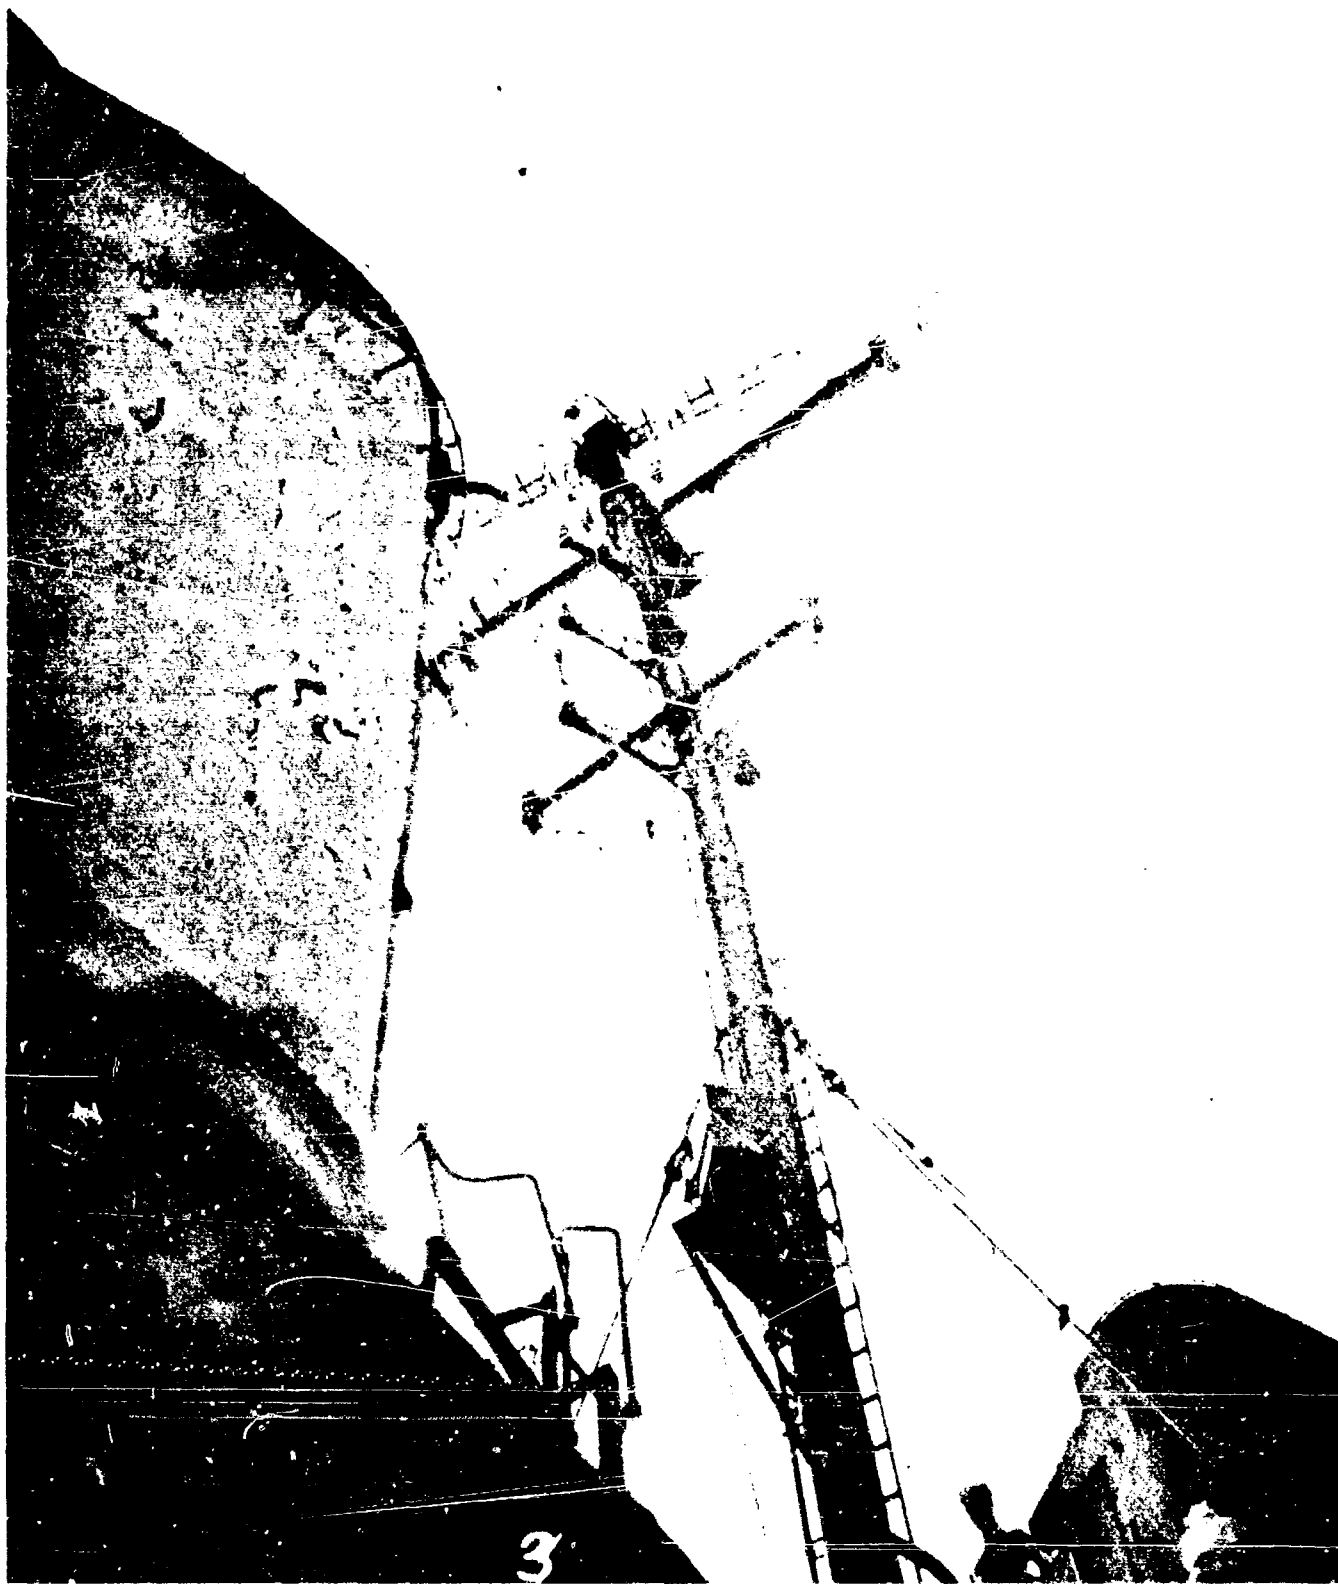
POST ABLE - FOREMAST. View of SC and other antennas. A slight bend in mast is visible, but it did not cause any damage to equipment.

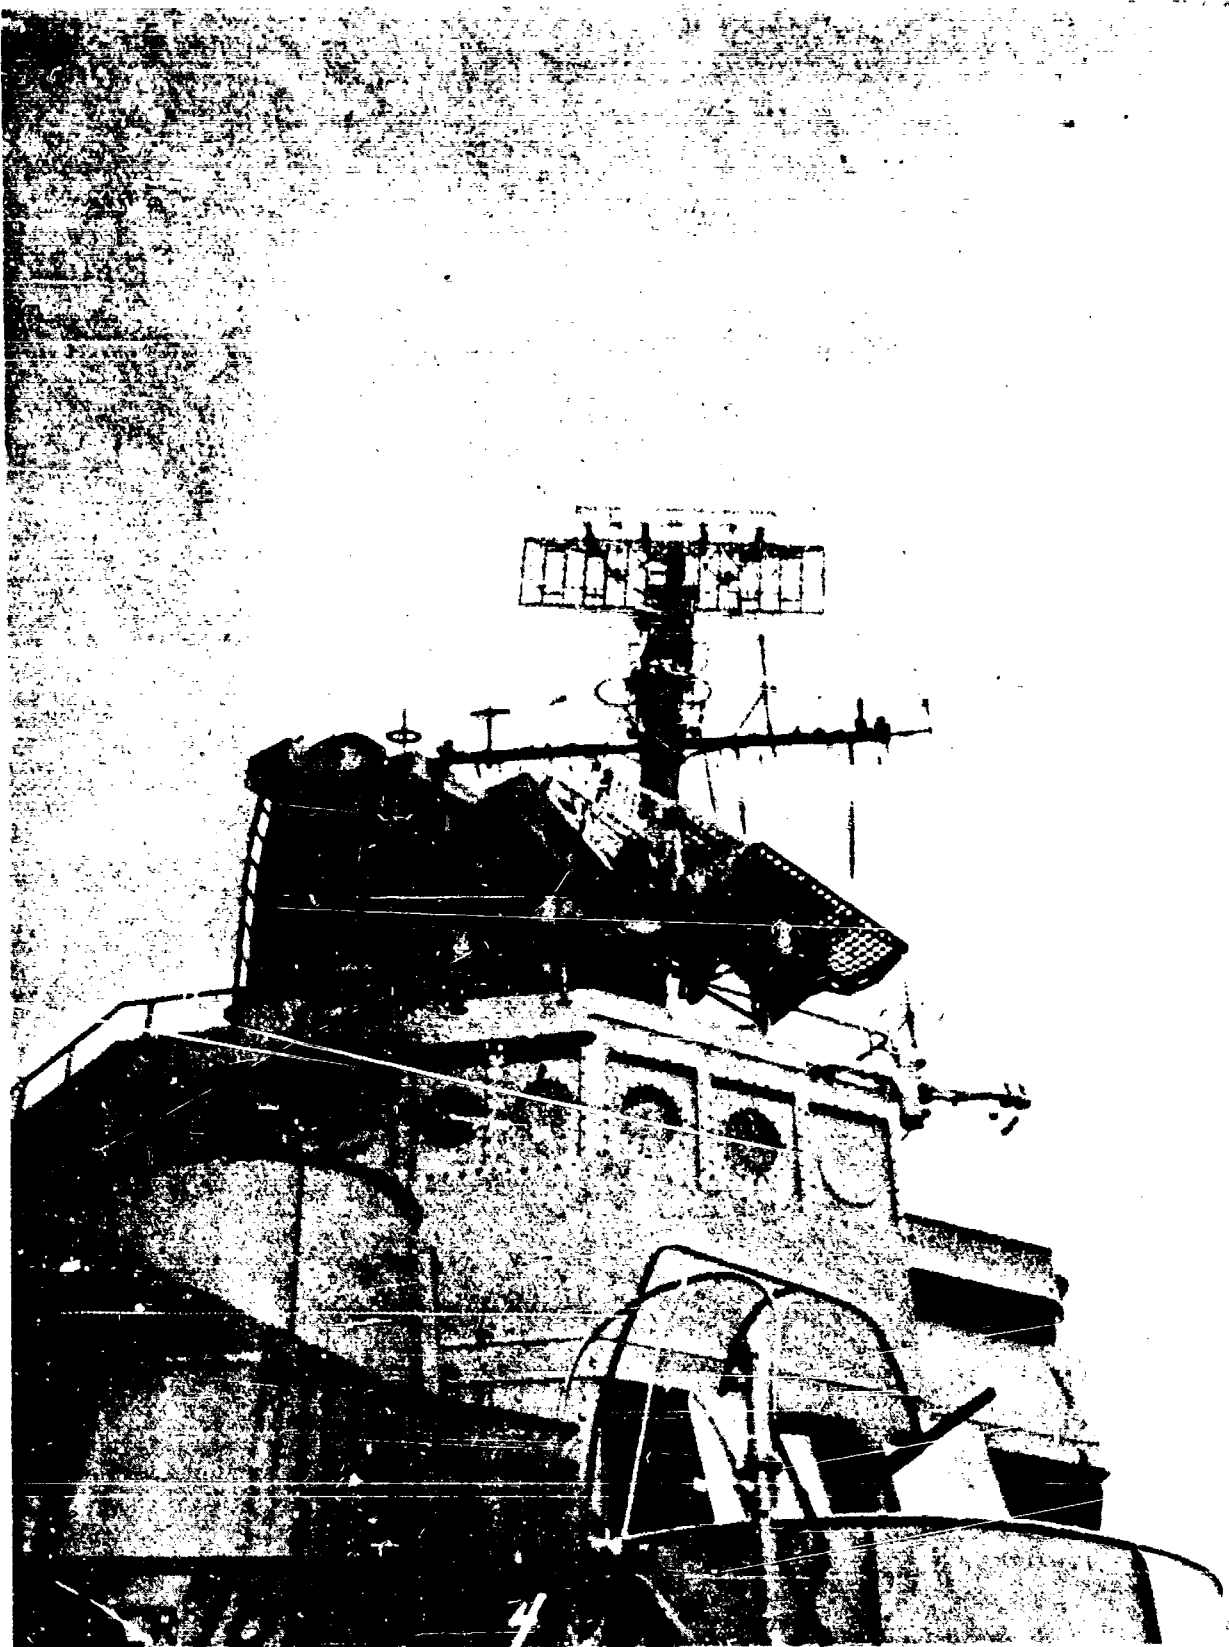
POST ABLE - FOREMAST AND MAIN BATTERY DIRECTOR. Neither the SC or MK 4 radar antenna was materially damaged.

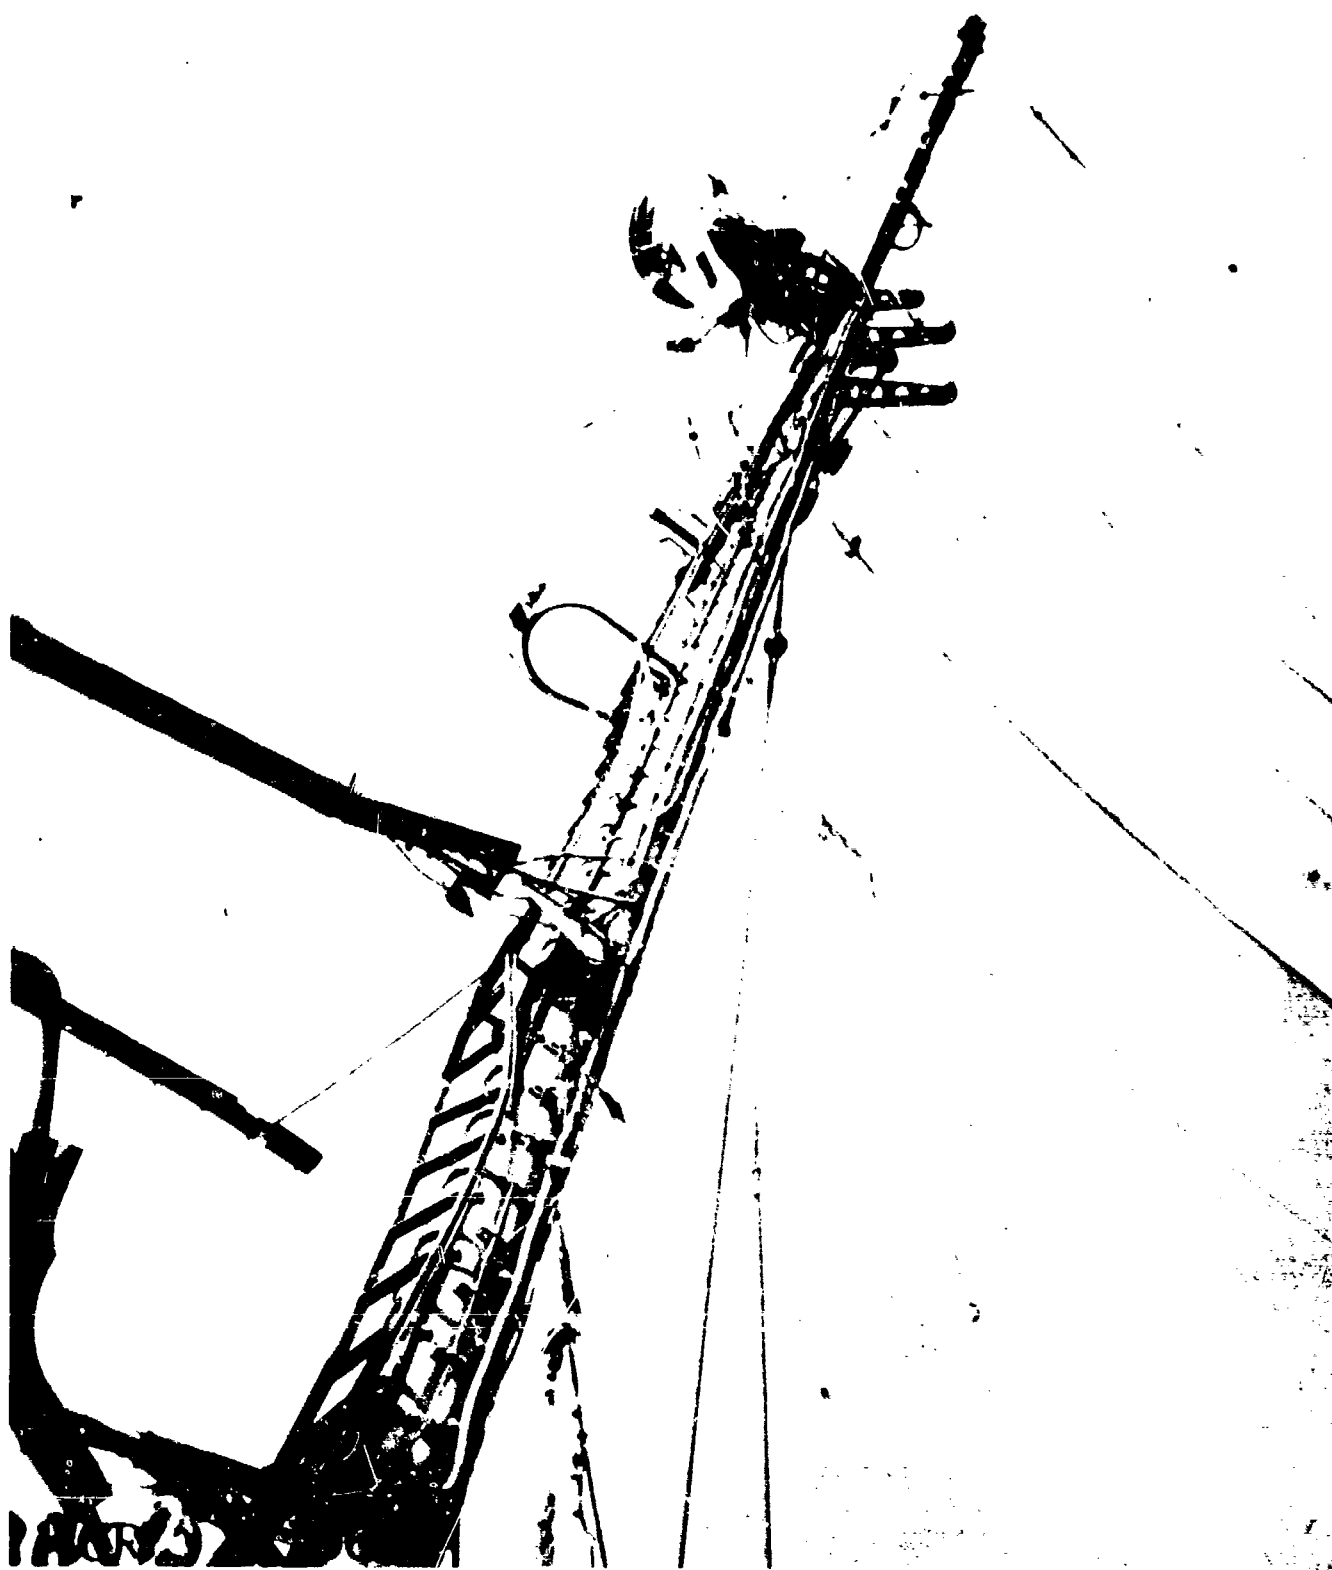
POST ABLE - MAST. View from below the crossarm shows how the mast bent aft at its base and tore away from its bracing. The top section bent forward about 60° & the crossarm, leaving the SG antenna about 40° off normal position.

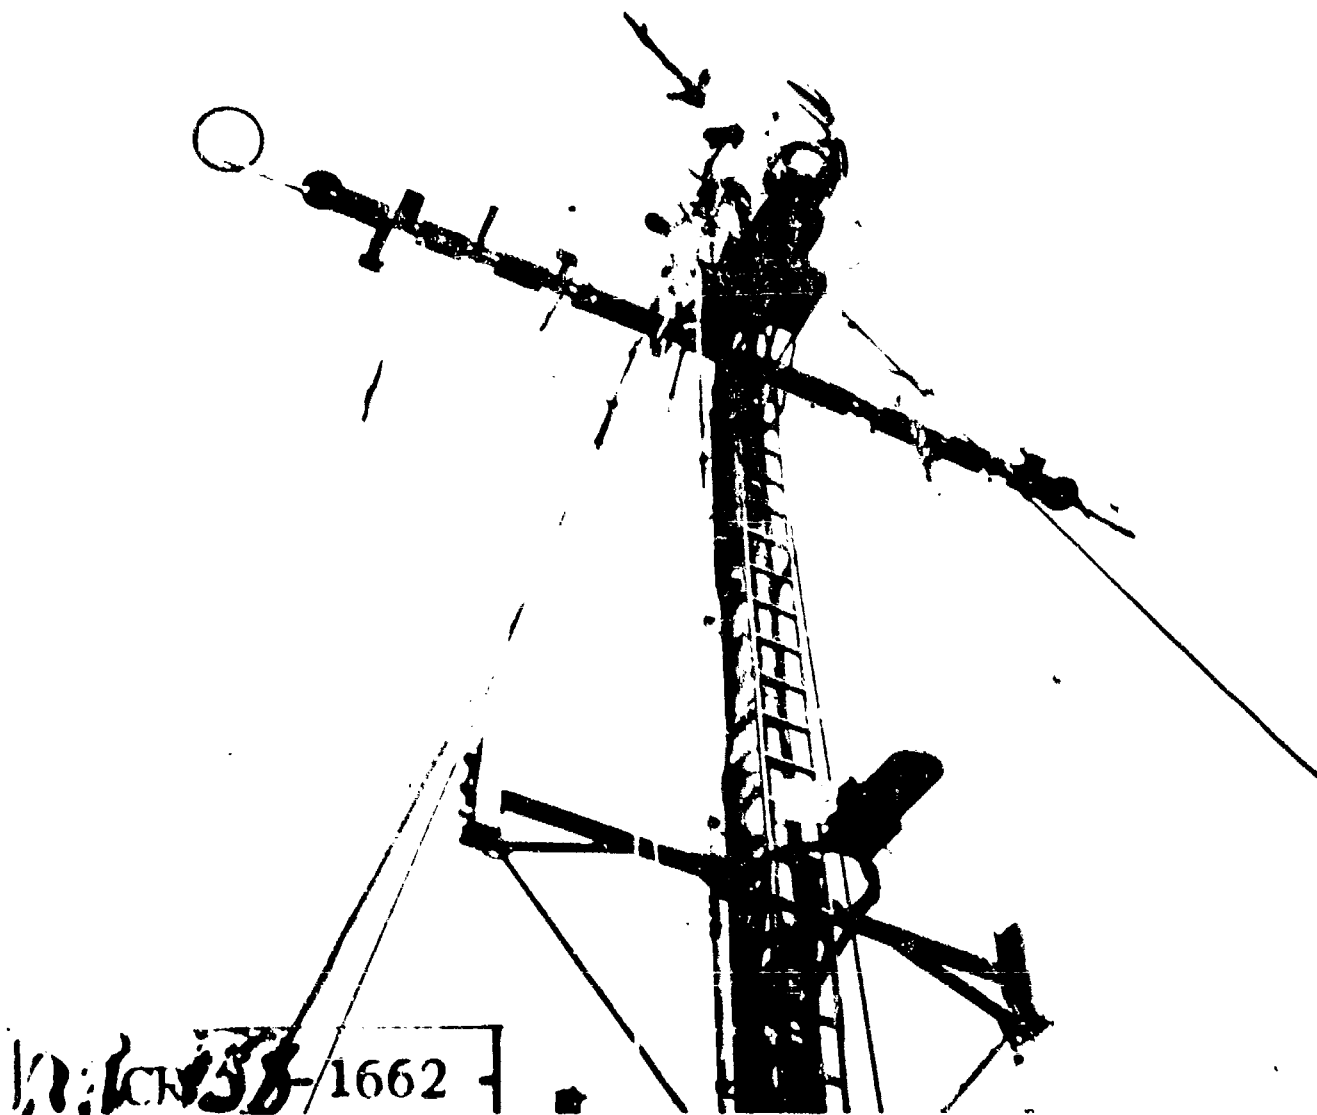
POST ABLE - MAINMAST. SO-2 antenna was swept away from the top of its pedestal (arrow). The pedestal was left intact. The SG antenna and various other antennas on the yardarm were left intact.

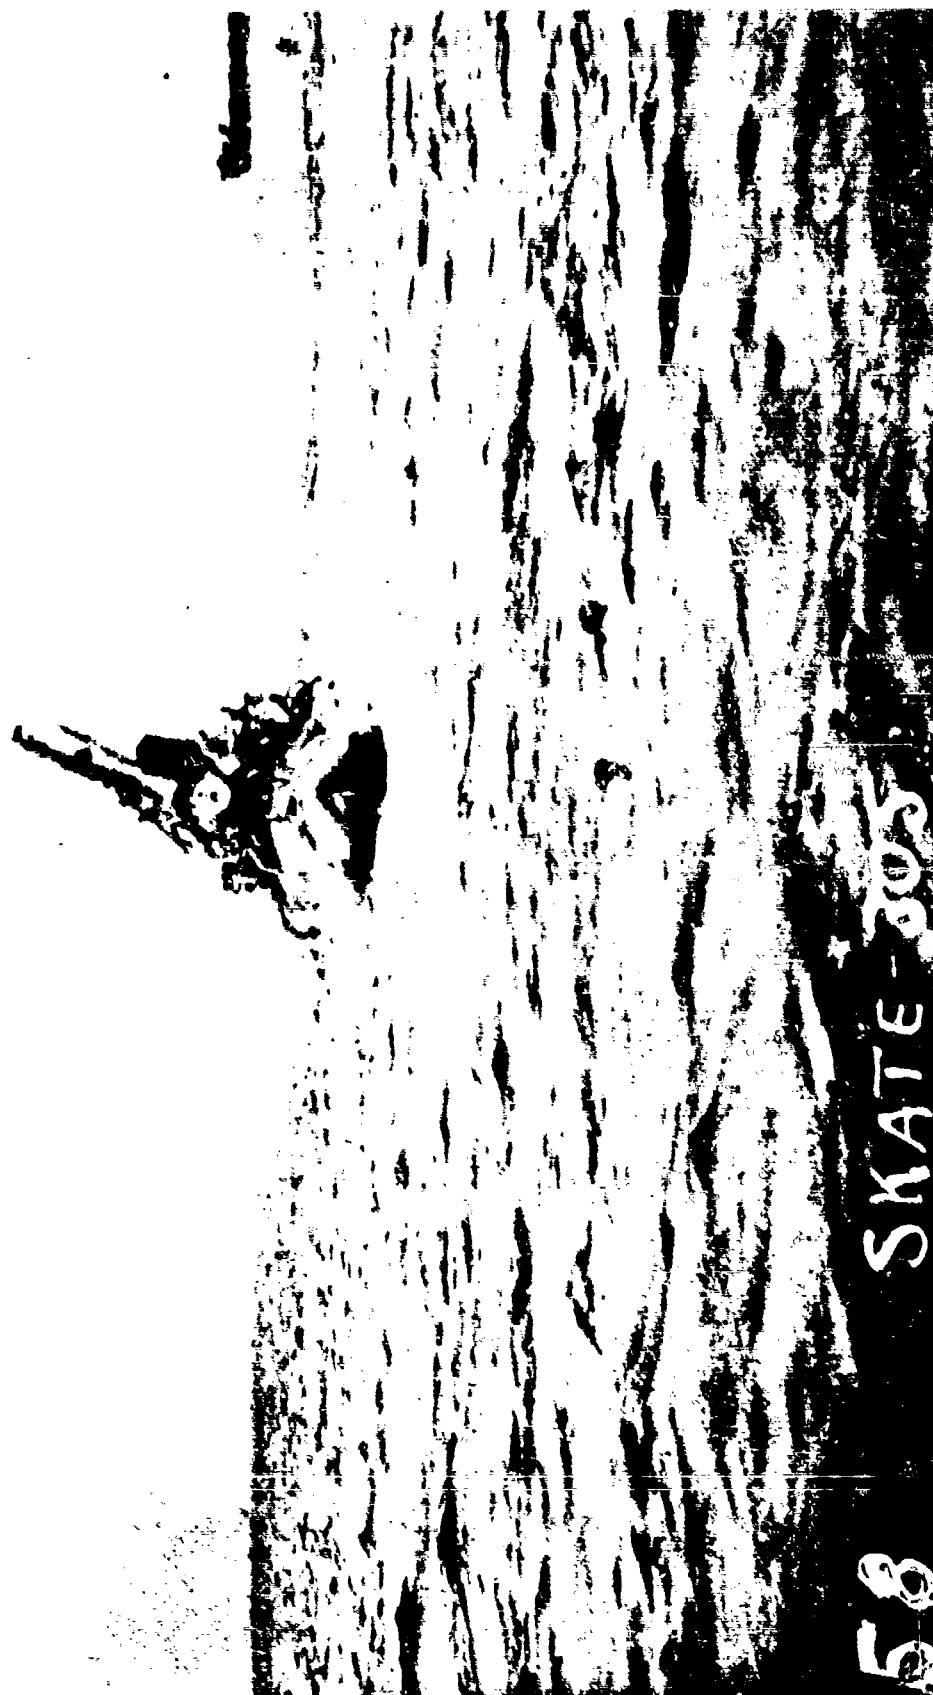
POST ABLE - STERN VIEW. Showing general topside damage.

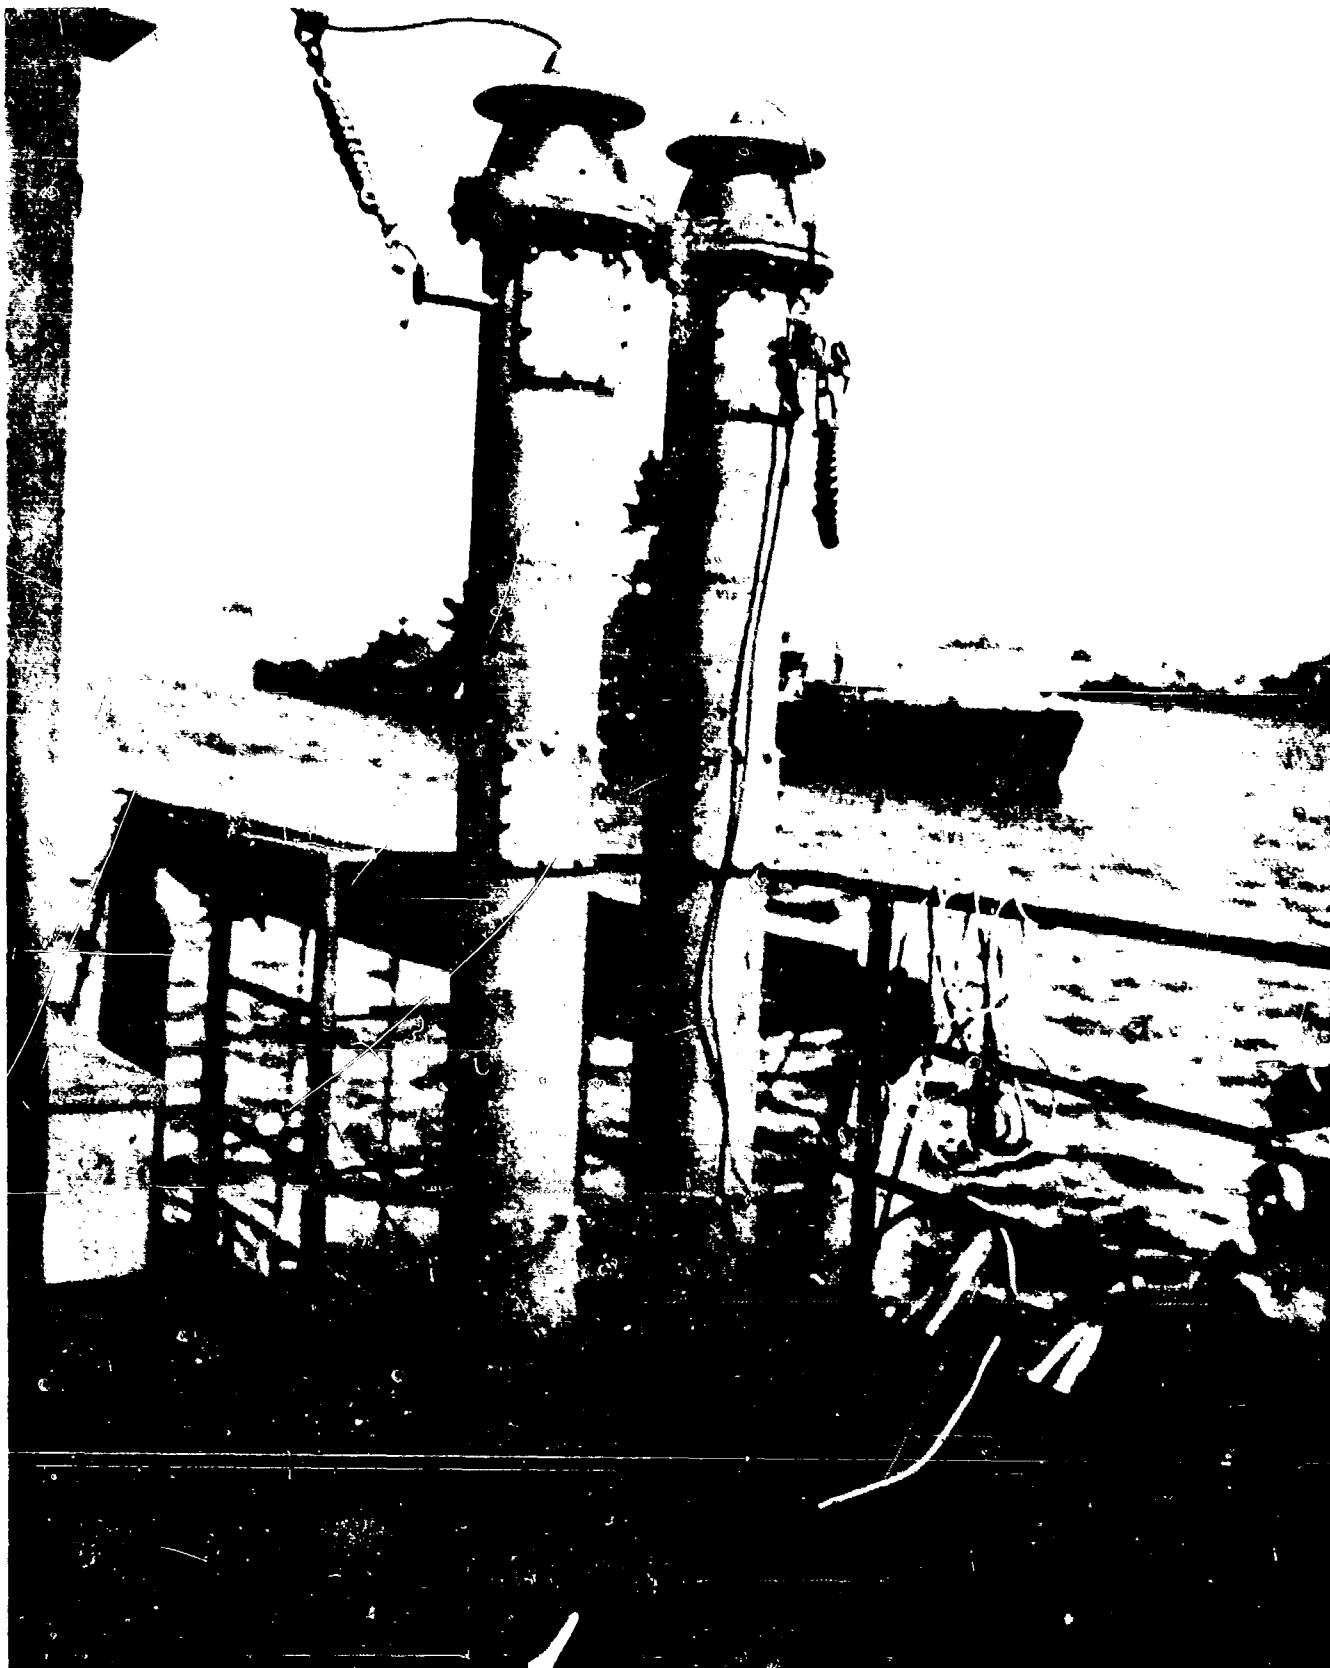
POST ABLE - ANTENNA TRUNKS. Outboard antenna blown down.
